NASA/TM-2008-215525
NESC-RP-06-61/05-036-E

Failure Analysis Study and Long-Term Reliability of Optical Assemblies with End-Face Damage

**Failure Analysis Study and Long-Term Reliability of Optical
Assemblies with End-Face Damage
Technical Assessment Report**

***Phase I: International Space Station (ISS) Termini Root Cause
Analysis Report***

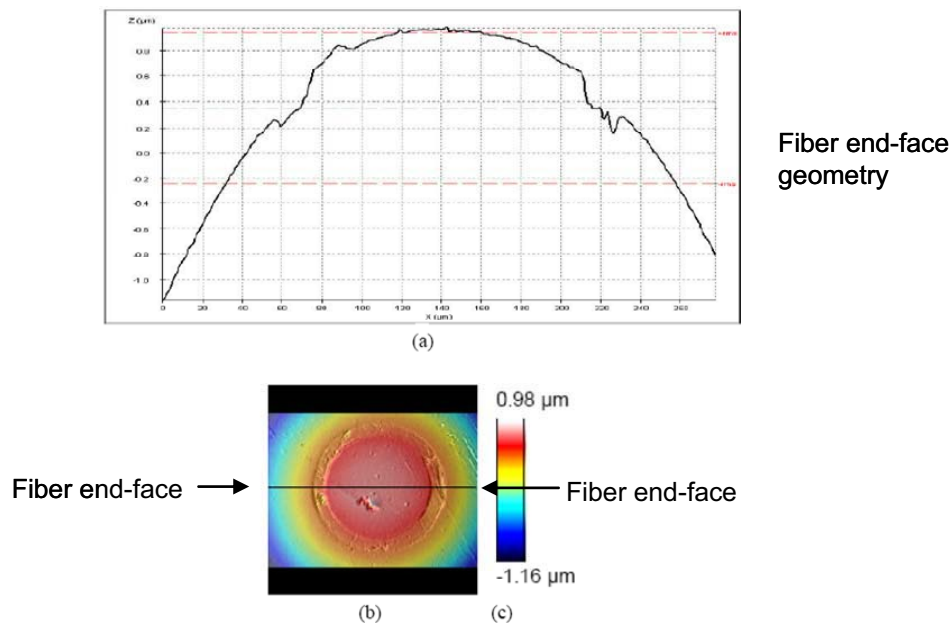
Figure 4.0-2. Confocal Profile

In many applications, a physical contact connection is implemented to mate fiber optic connectors such that the insertion losses are reduced. In the case of this connector, the high vibration levels originally used to “qualify” the connectors for military standard applications showed data indicating that the terminus/connector system should not be of a physical contact type. Therefore, the same processes were specified in this application. For a “concave” polish, it is imperative that the glass end-faces do not come in contact with one another in order to comply with the military standard method and reasoning for non-contact. As stated in OHB’s “Fibre Optic Manufacturing Procedure” Section 4.6: “Inspect the profile of the terminus end-face under 40X magnification. The surface should be slightly concave with the face of the ceramic tip.” This is not an effective method for determining the fiber’s profile. Figure 4.0-1 shows what the profile looks like at 40X magnification. The end-face appears to be flat, and not protruding. This method is non-conclusive for true determination of the end-face profilometry. The profile should be determined using an interferometer or confocal microscopy as illustrated in Figure 4.0-2. The confocal data clearly shows the end-face of the fiber to be convex, which should have failed inspection.

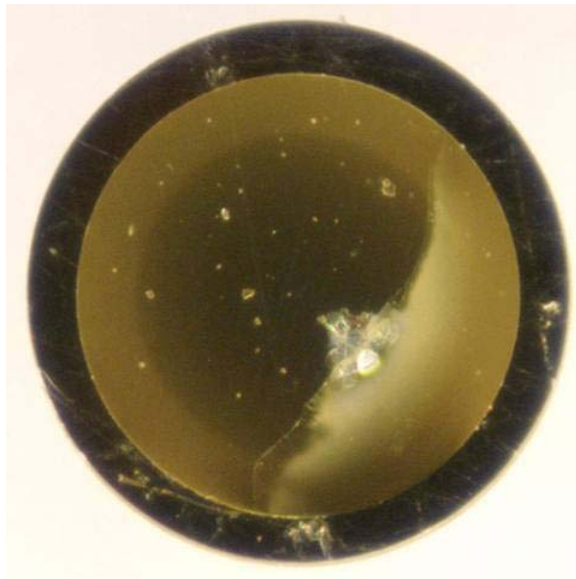
Figure 7.1-2. Dark Field Image

The origin of the impact fracture needs to be observed closer. If a higher magnification were used with the microscope, the features of the fracture would not be clear, and no solid conclusions could be made. To analyze the fracture closer, the terminus was observed using SEM.

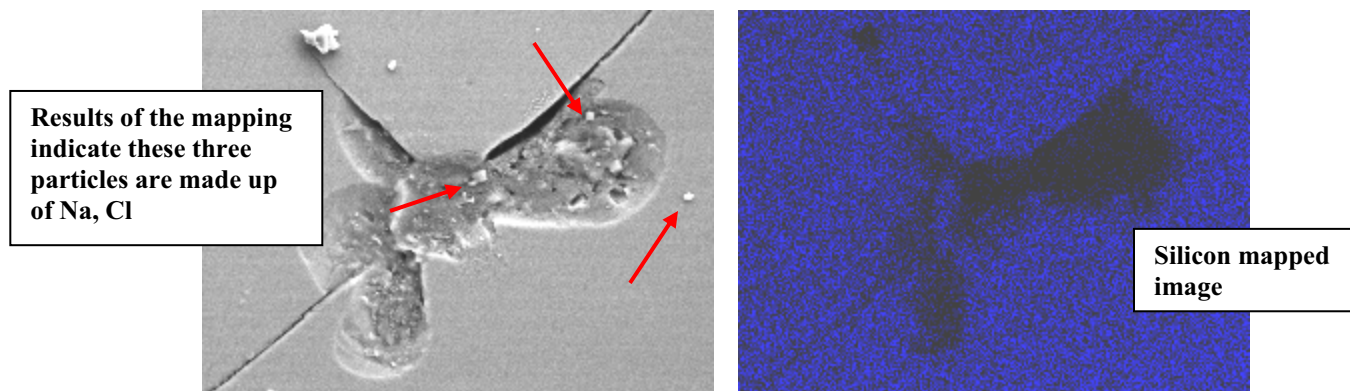
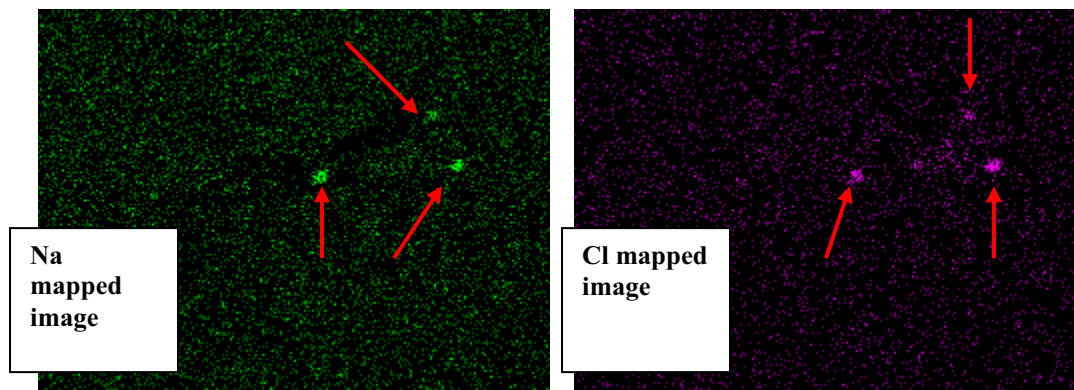
Figure 7.1-6. Elemental Mapping of Si, Na and Cl

The discovery of salt crystals in the glass was puzzling. To identify where the salt crystals are located on the end-face, elemental mapping was performed. Elemental mapping was not effective at 500X magnification to locate small traces of certain elements, so to locate Na and Cl, a higher magnification was used. Figure 7.1-6 shows the results when this sample was mapped for Si, Na, and Cl.

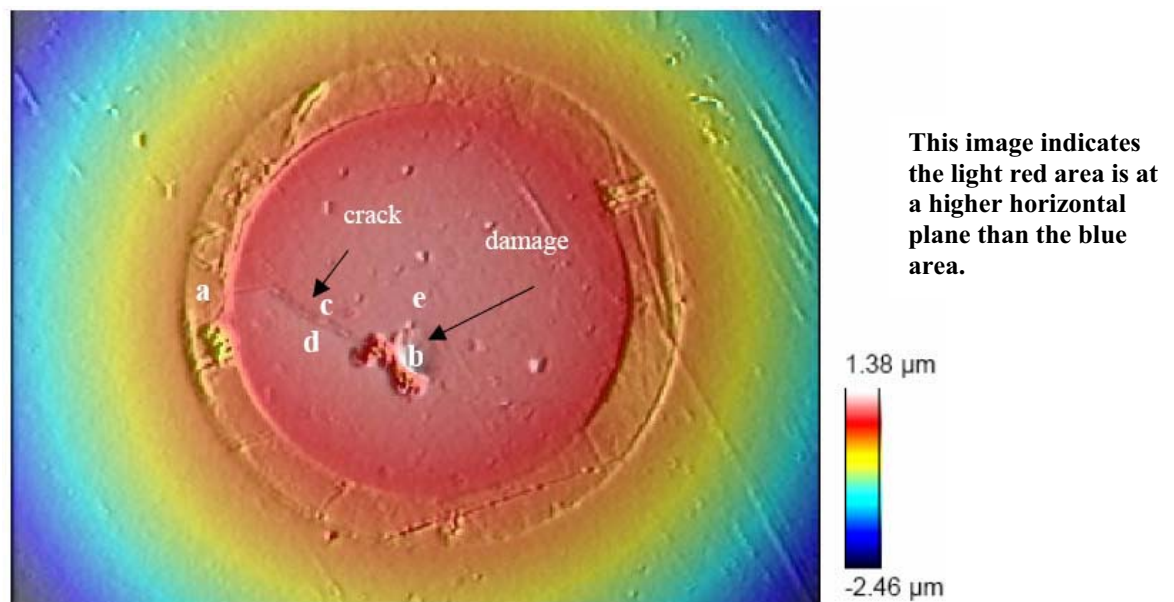
Figure 7.1-7. Confocal Topographical Image

Optical microscopy and SEM do not have the ability to generate a profile of the end-face so confocal microscopy is performed. Confocal microscopy (Figure 7.1-7 and Table 7.1-1) will generate a topographical map and a profile in the X-Y axis. It was discovered that the fiber has a convex end-face rather than concave.

These termini are supposed to be manufactured with a slight concave end-face as observed in Figure 7.3-5. This is per the manufacturing procedure [ref. 4]. Since this particular sample has a convex end-face, the fiber more than likely contacted what it was mated to and was damaged.

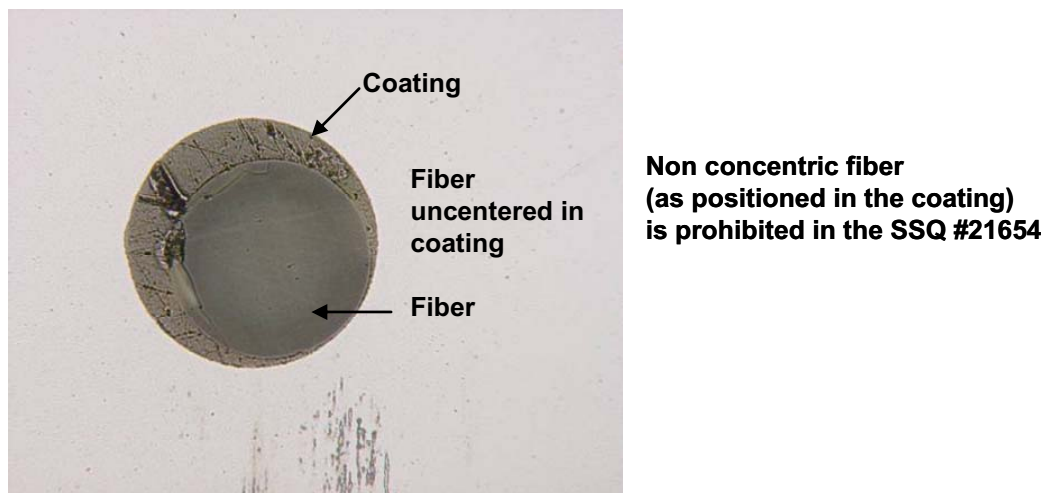
Figure 7.2-2. Magnification of 200X Optical Image

At 500X, a gouge in the coating has an interesting V-shaped pattern and is quite a deep cut. It was noted that the point of the V and the heavy damage at the origin of the break do not line up. The origin of the break suggests an impact fracture from the side. This fracture could easily have been caused by thermal-induced stresses from non uniform CTE distribution around the fiber

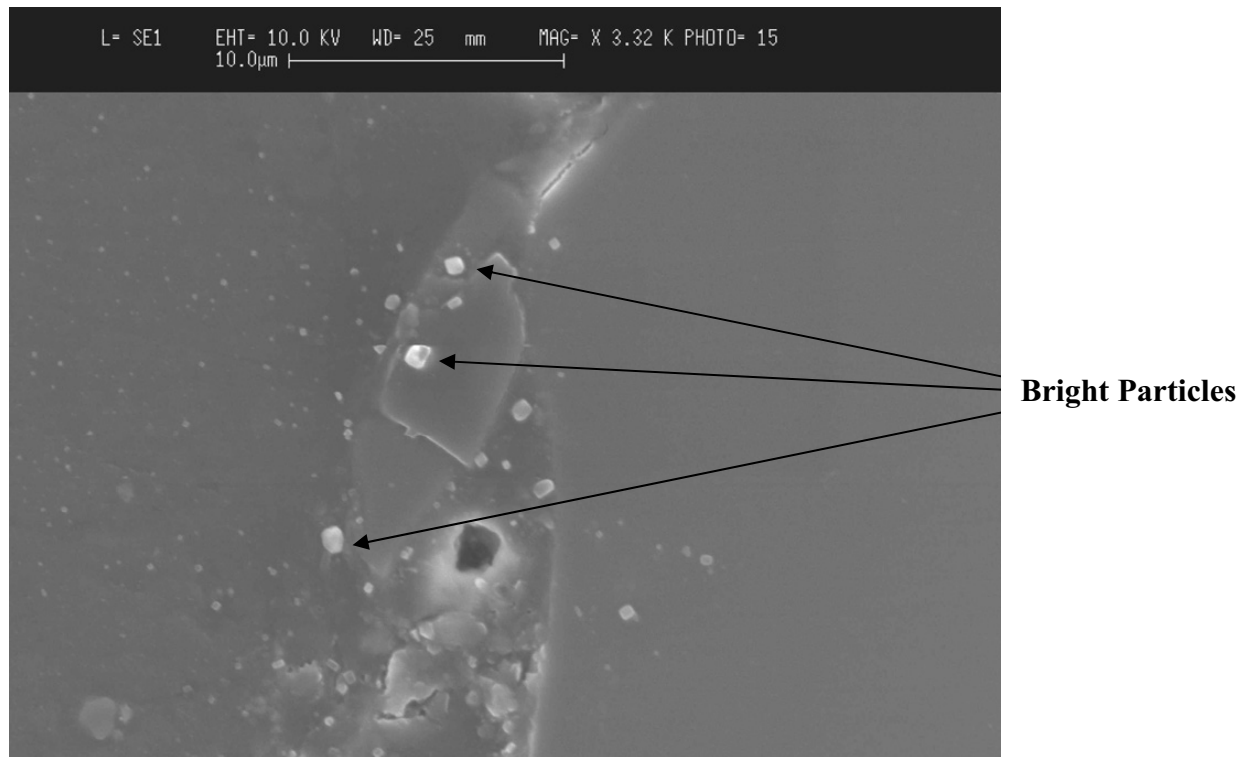
Figure 7.2-5. Magnification of 3,320X SEM Image

An EDS data analysis was performed on one of the “bright” particles and traces of oxygen, Na, magnesium, aluminum, Si, Cl, potassium, and calcium were found.

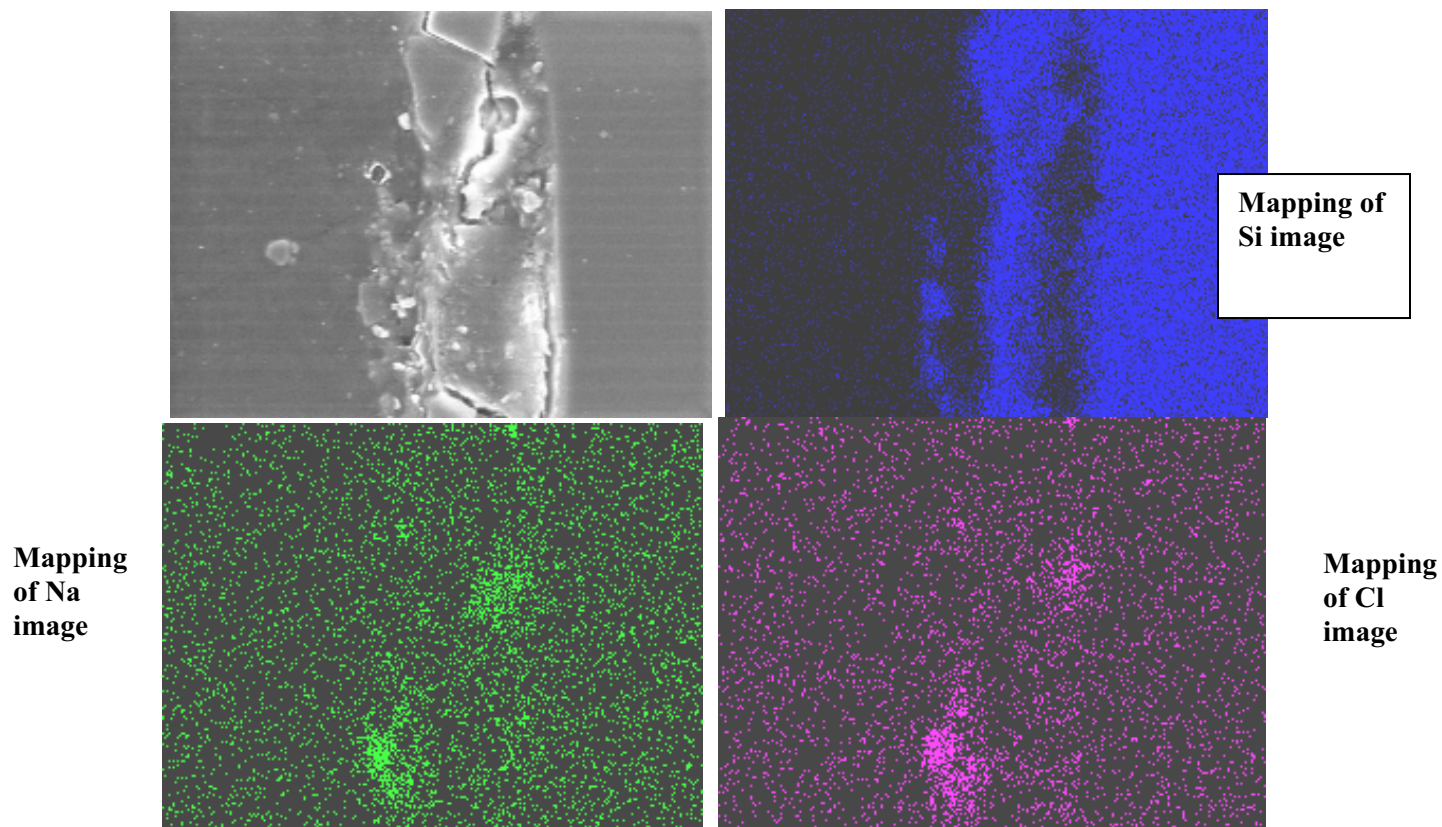
Figure 7.2-7. Elemental Mapping of Corrosion

Elemental mapping of the debris on this sample was performed very similar to the previous sample. At higher magnifications, traces of Na and Cl can clearly be identified. The bright areas of the images in Figure 7.2-5 are the elements that have been mapped. Refer to Figure 7.2-7.

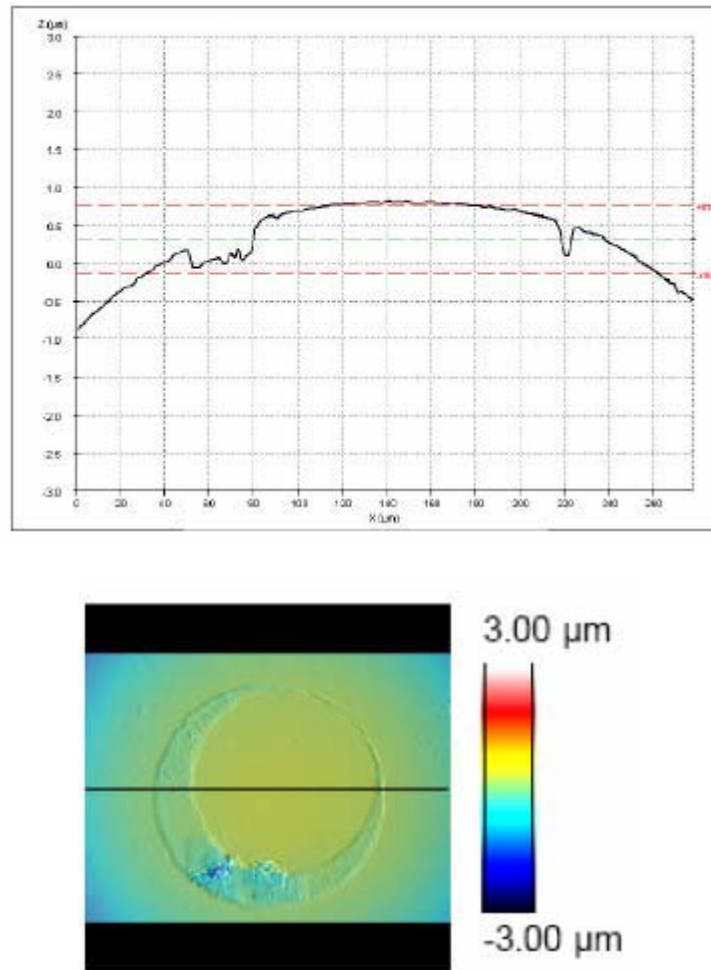
Figure 7.2-8. Confocal Data

Confocal microscopy data (Figure 7.2-8) indicates a convex profile of the end-face, which violates the specification. The radius of convex curvature is 9.0 mm.

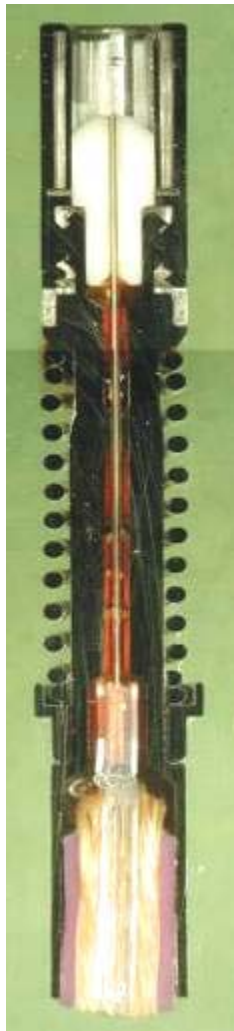
Figure 7.3-2. Cross-Section View of the Optical Fiber Termini

This sample was cross-sectioned to get a profile view of the fiber end, and identify features that have not yet been observed in other termini. There was some large metallic debris observed in Figure 7.3-2 that may have initiated the flaw.

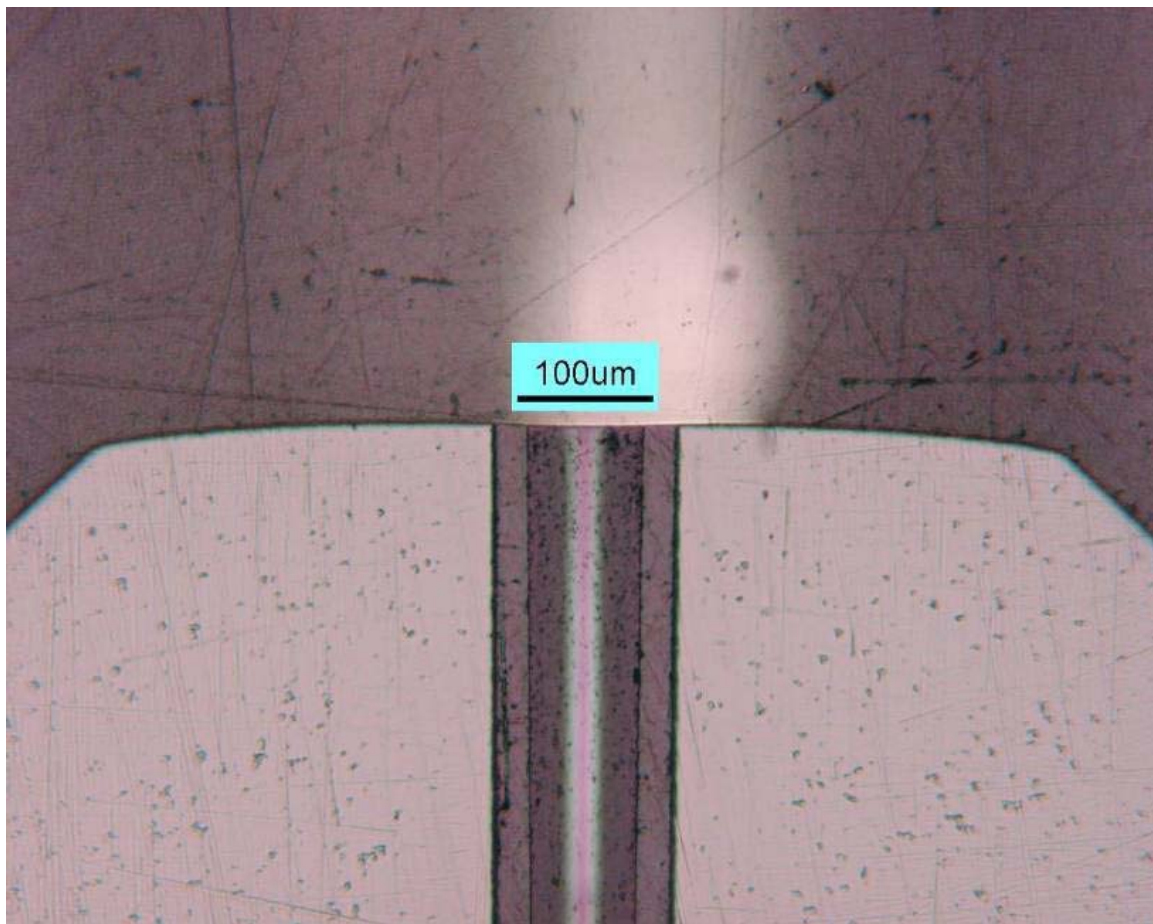
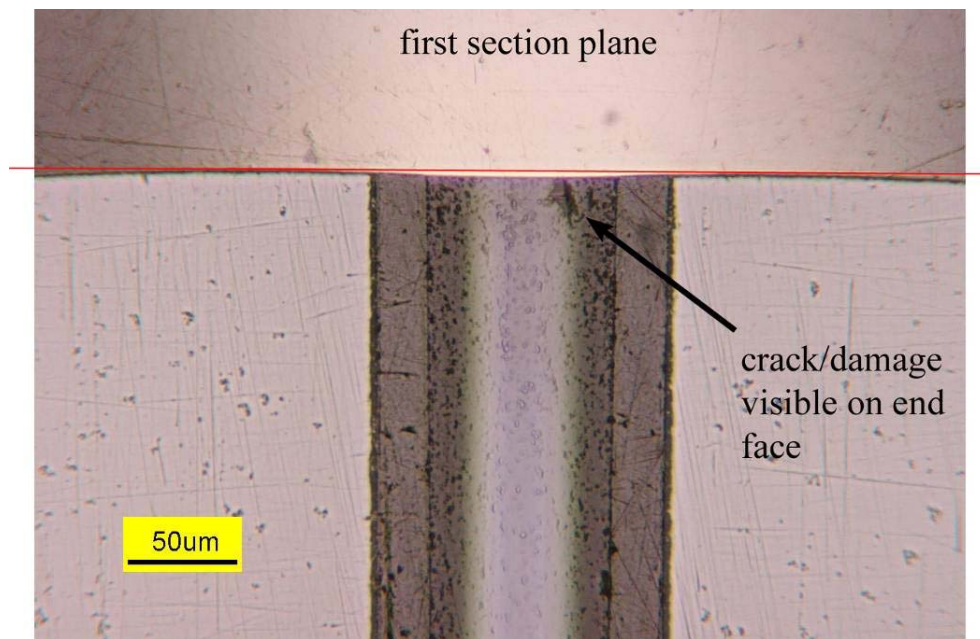
The magnified images in Figures 7.3-4 and 7.3-5 indicate (without a doubt) that the end-face is concave. This is by design so the glass does not make physical contact to another terminus end-face when mated into the connector. Note that the crack has not propagated all the way to the edge of the fiber, leaving the fiber intact.

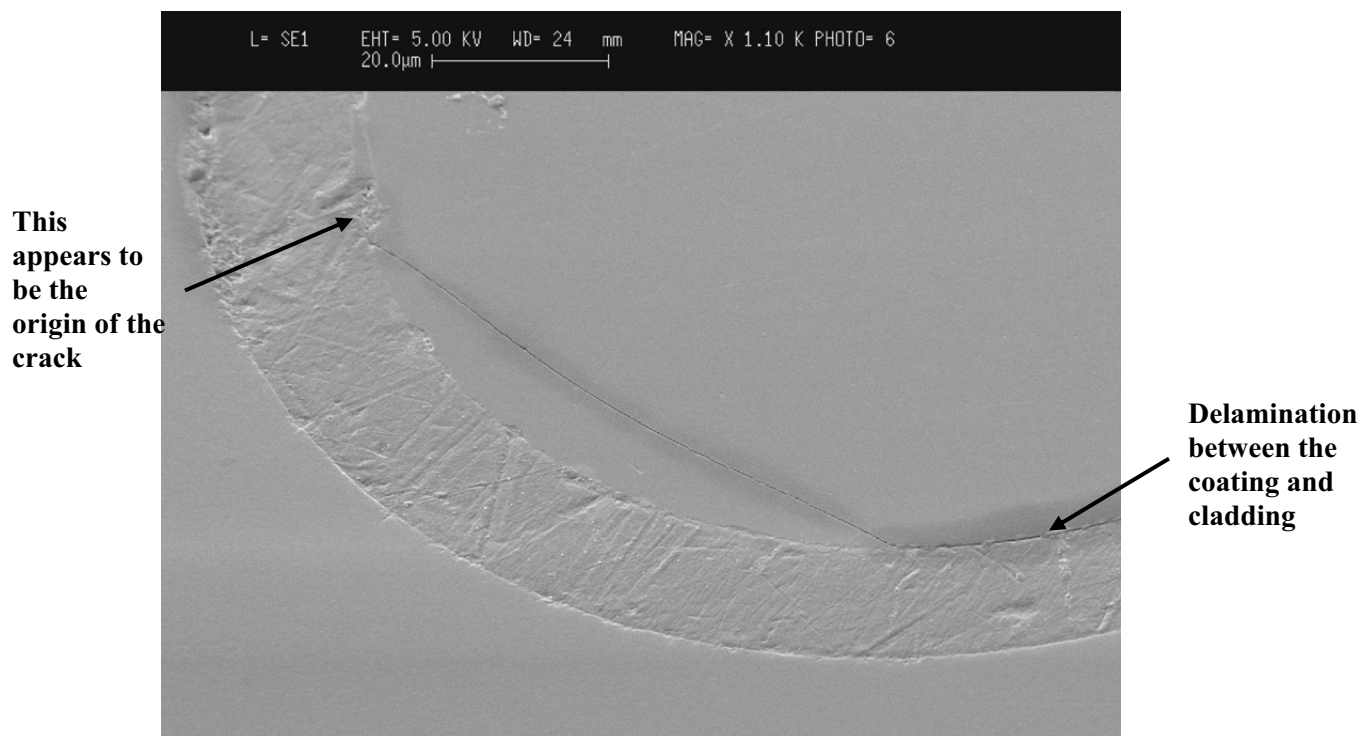
Figure 7.4-3. Magnification of 1,100X SEM Image

The SEM image taken at 1.1×10^3 magnification (Figure 7.4-3) shows an area suspected of being the break origin, a crack propagating through the cladding, and delamination between the coating and glass where the crack ends. If this is in fact the origin, the crack could have propagated with the help of shrinkage of the epoxy.

1. The location of the suspected origin suggests the flaw started from the edge of the fiber. This likely was caused by an abrasive particle used to wipe the fiber.
2. The scratches observed in Figure 7.4-1 are fairly deep, and this terminus should have been polished with a finer grit lapping film to remove them.
3. Debris on the end-face suggests the cleanliness was not maintained.

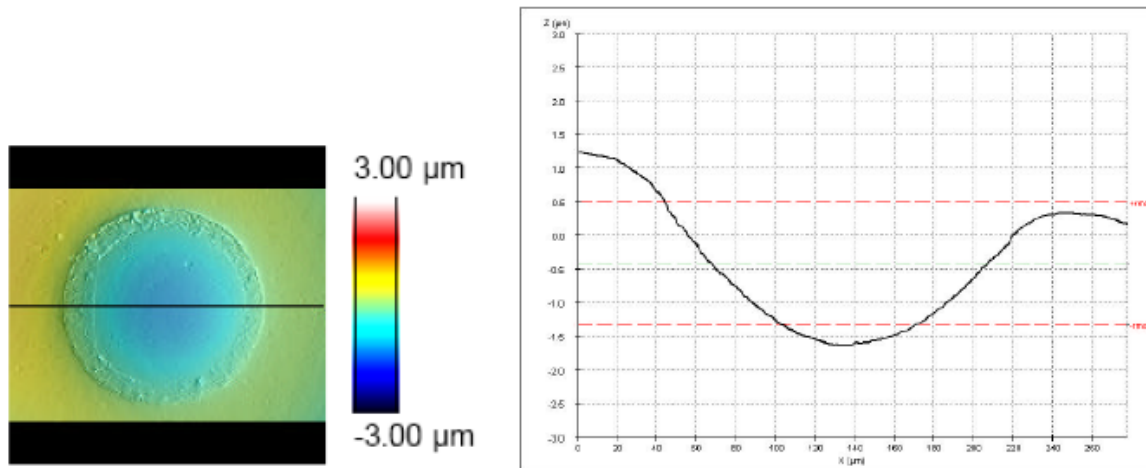
Figure 7.4-6. Confocal Data

The confocal microscopy data (Figure 7.4-6) indicates the end-face has a concave profile. This conforms to the manufacturing procedure [ref. 3]. The radius of curvature measures 2.0 mm.

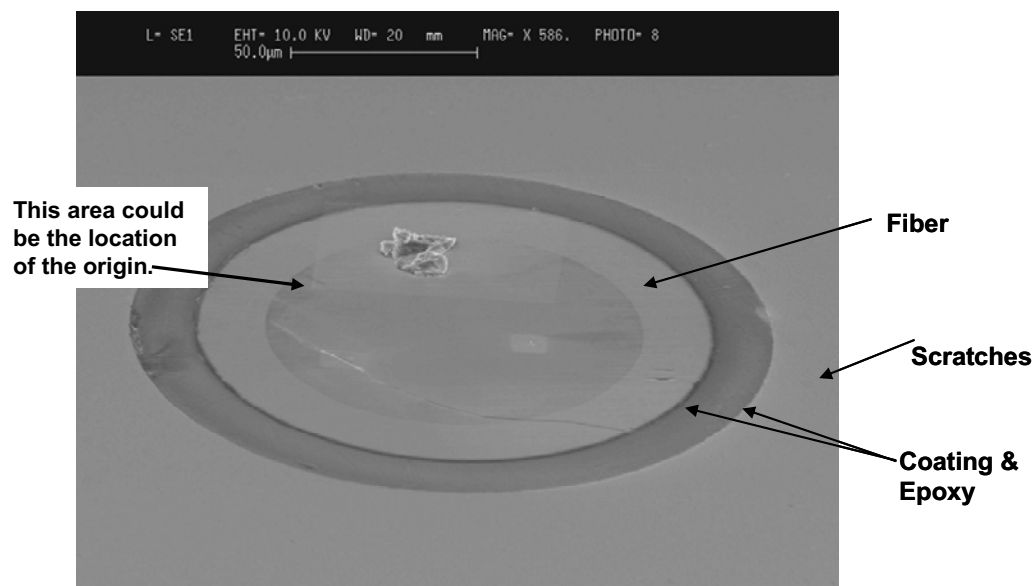
Figure 7.5-4. Magnification of 586X SEM Image

The SEM image taken at 586X magnification (Figure 7.5-4) identified two small scratches in the cladding area that appeared to be debris under the microscope. Connecting the termination when debris was present was likely the cause.

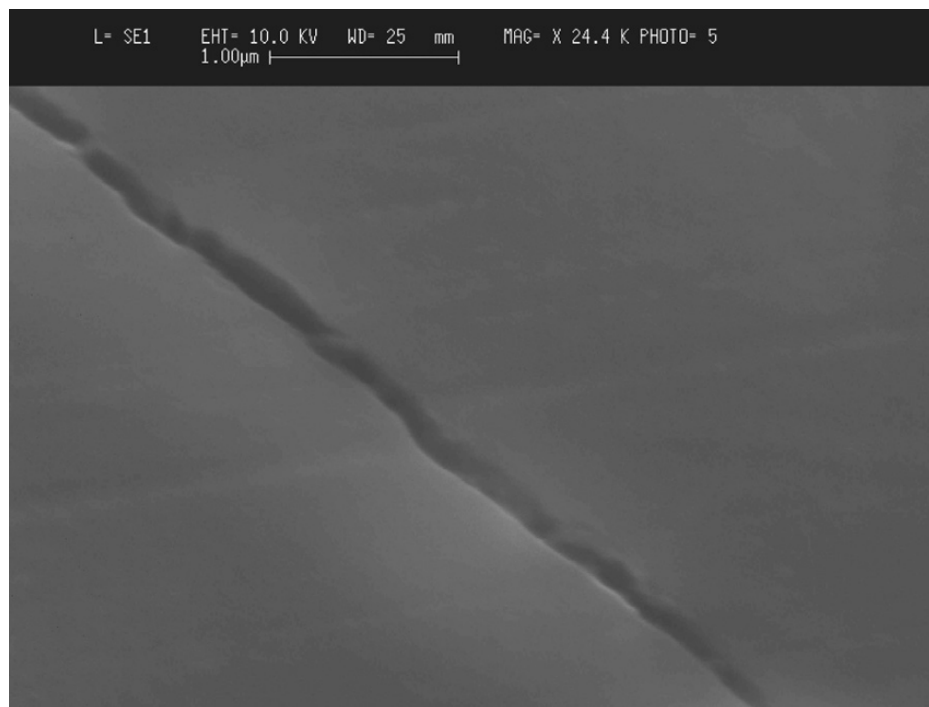
Figure 7.5-5. Magnification of 24,400X SEM Image of Crack

At 24.4×10^3 magnification, a view of the crack through the glass can be observed. This image does not confirm if one side of the crack is depressed or not. AFM would have to be performed to make a determination.

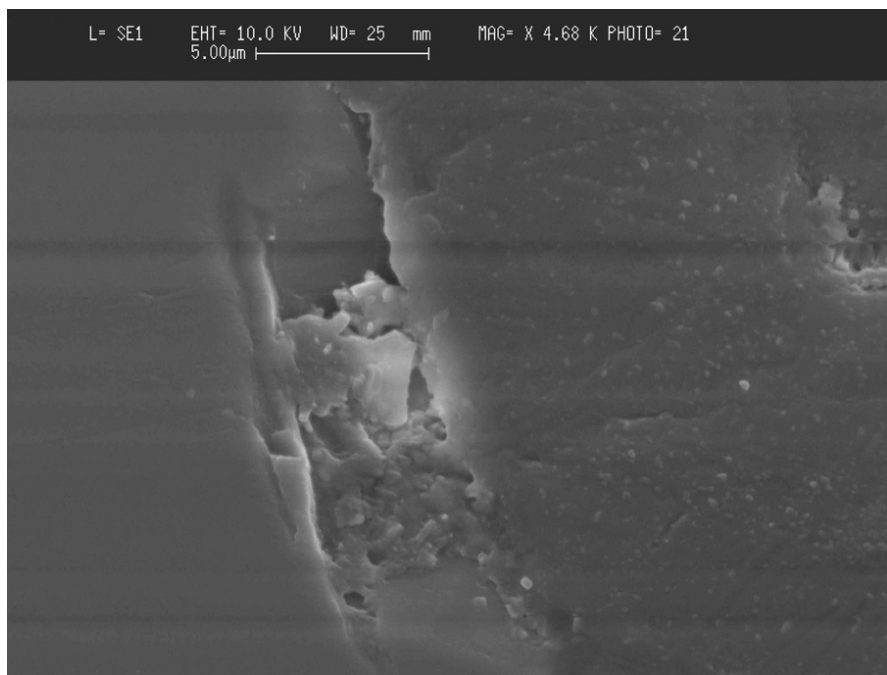
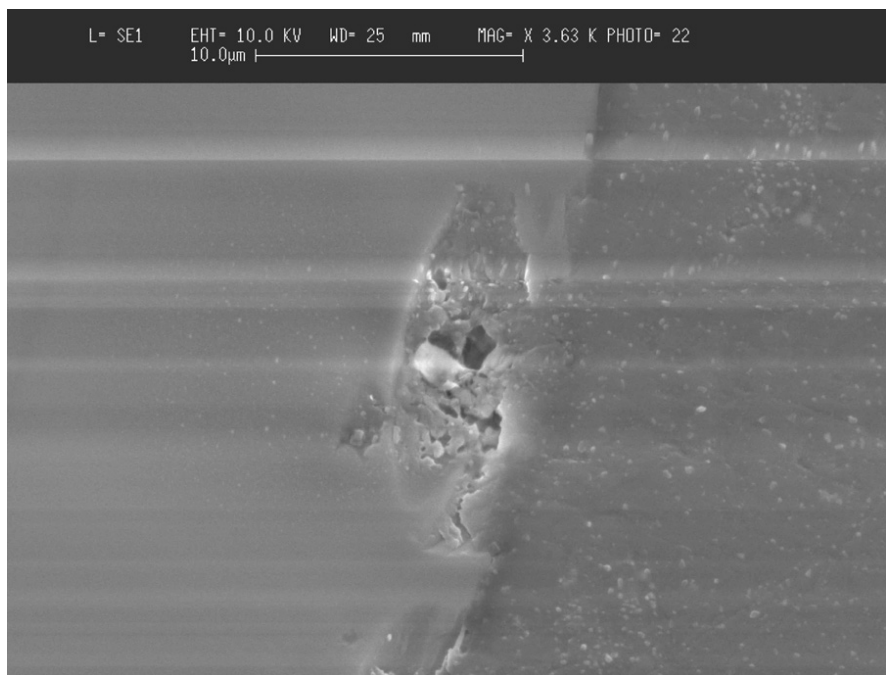
Figures 7.6-3 and 7.6-4 show a corrosive attack in some of the damaged areas, similar to what was observed on some of the other termini.

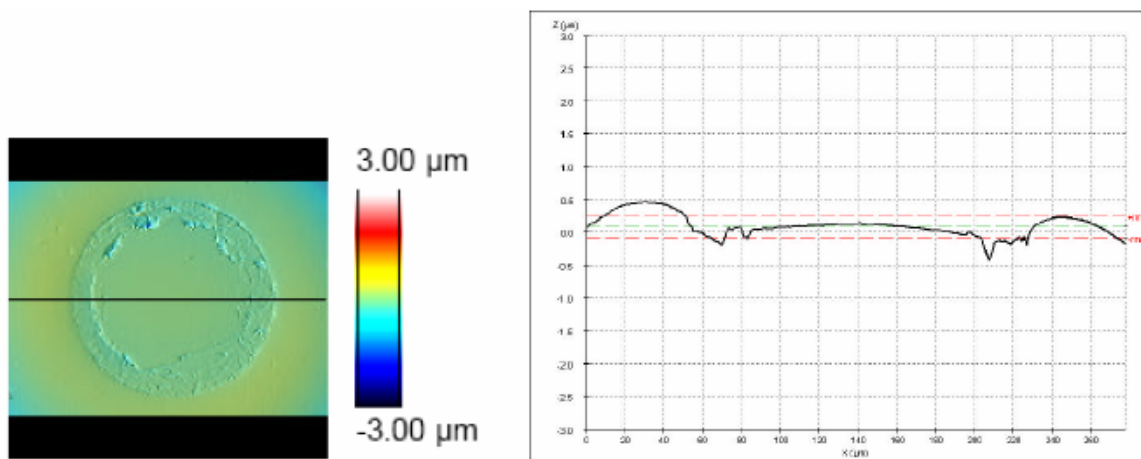
Figure 7.6-7. Confocal Data

Confocal microscopy was performed and indicated the fiber end-face is convex (Figure 7.6-7). The radius of curvature is 13.5 mm.

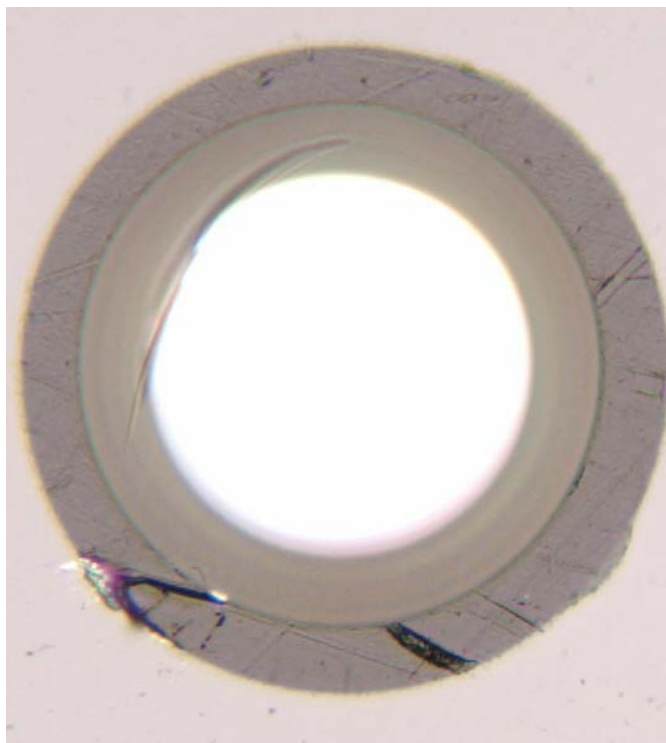
Figure 7.7-2. Bright Field Image @ Magnification of 200X

These termini are inserted into a sleeve when mated. The signature of the scratch might indicate the end-face was not clean when the connection was made.

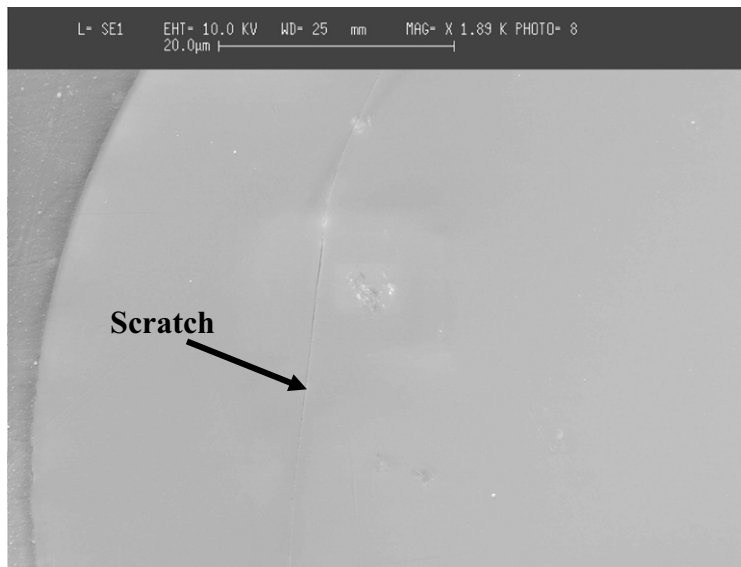
Figure 7.7-4. Scratch at Magnification of $1.89 \times 10^3 \times$

Under SEM, the surface scratch is not quite as visible at $1.89 \times 10^3 \times$ magnification (Figure 7.7-4), but at $3.63 \times 10^4 \times$ magnification, the indentation from the scratch is very visible (Figure 7.7-5).

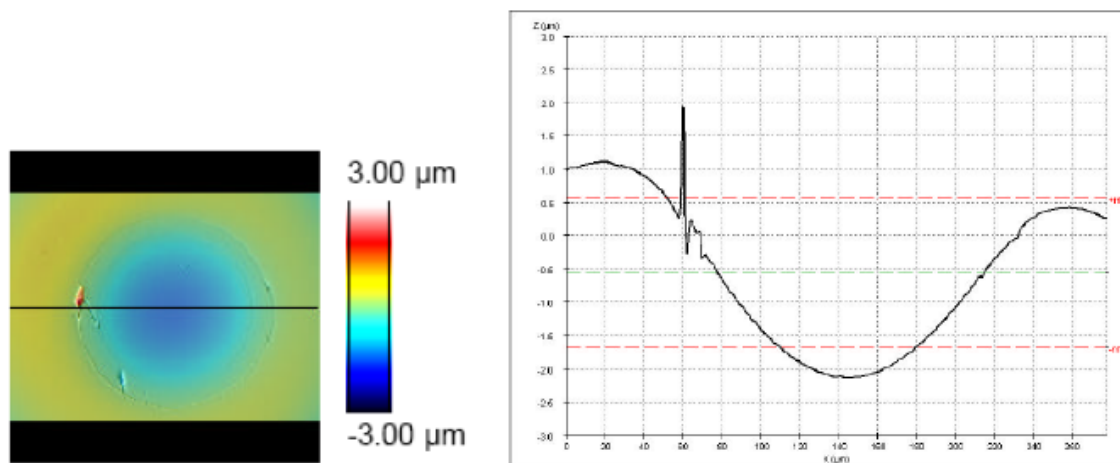
Figure 7.7-6. Confocal Data

Confocal microscopy (Figure 7.7-6) indicates the end-face is concave per requirements of the manufacturing procedure [ref. 3]. The radius of curvature is 1.4 mm.

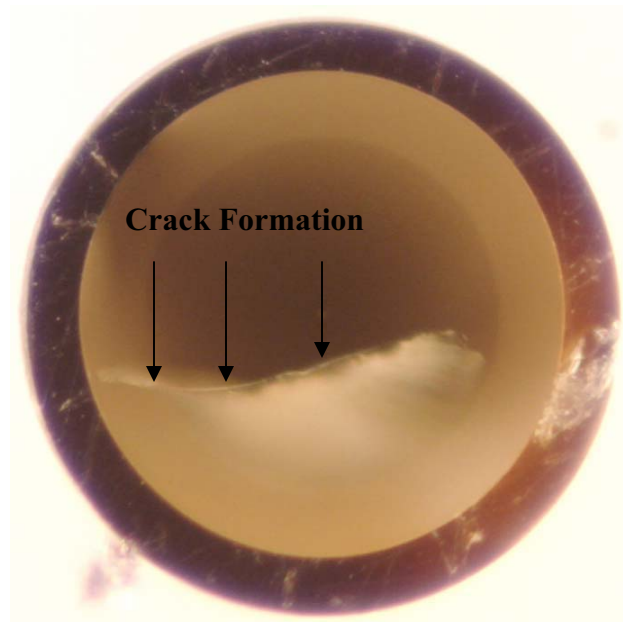
Figure 7.8-3. Dark Field Image at Magnification of 200X

At 200X magnification (Figure 7.8-3), a crack formation can be seen, and the “smudge” appears to be sub-surface cracking. Optical microscopy is not enough to identify an origin of the crack, so SEM will need to be performed.

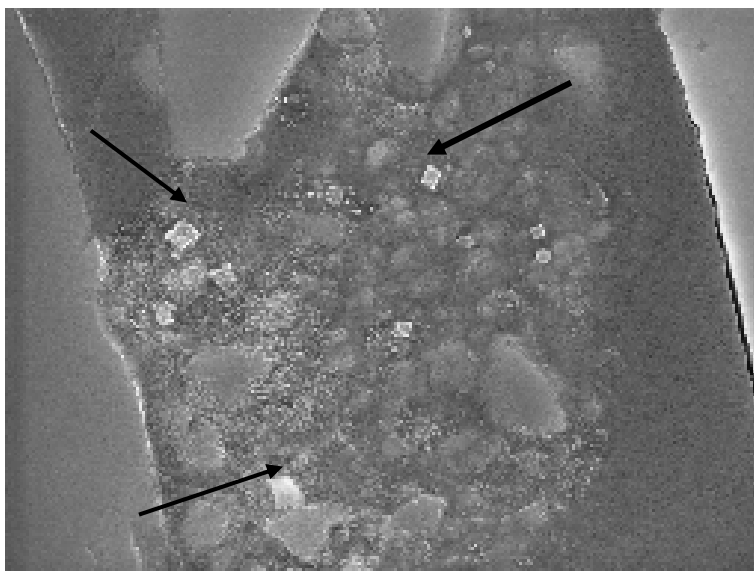
Figure 7.8-7. Visible Crystals in the Polyimide Coating

At higher magnifications of the corrosive area, crystals can be observed. These crystals appear to be salt crystals.

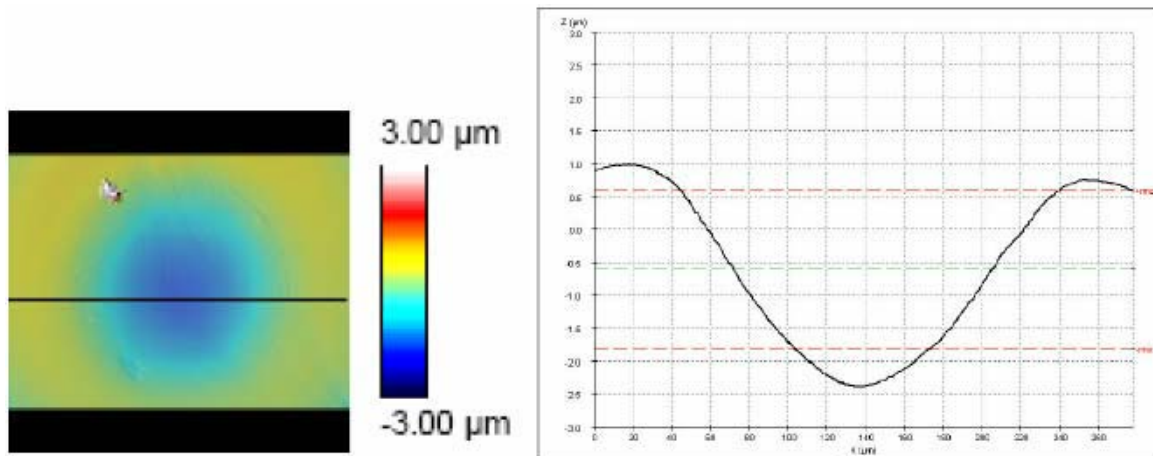
Figure 7.8-9. Confocal Data

1. The origin of the crack does not appear to be on either end, so it may have originated in the middle.
2. The cleanliness of the termination was not maintained.
3. Deep scratches indicate an improper polishing procedure was conducted.

Crack propagation occurred due to the deep scratches. The scratches are linear, which is an indication the fiber was wiped with an abrasive material, or remnants of the coarse lapping film were not removed during the final stages of polishing.

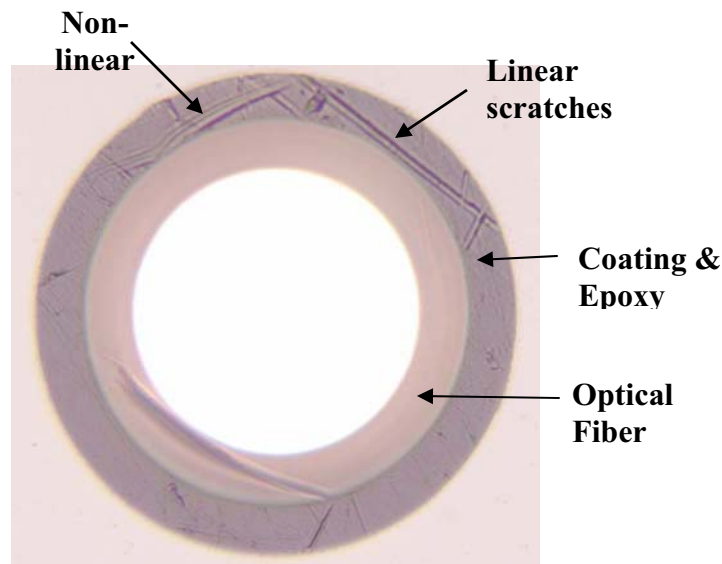
Figure 7.9-1. Bright Field Image at Magnification of 200X

This sample has damage very similar to HMU-303 P3-DAIU SKT C, whereas it appears to have been connected with debris present on the end-face. The scratches in the coating are evidence of a foreign substance being dragged or scraped in a non-linear direction. There is some unidentified debris in the core region that will need to be analyzed with EDS.

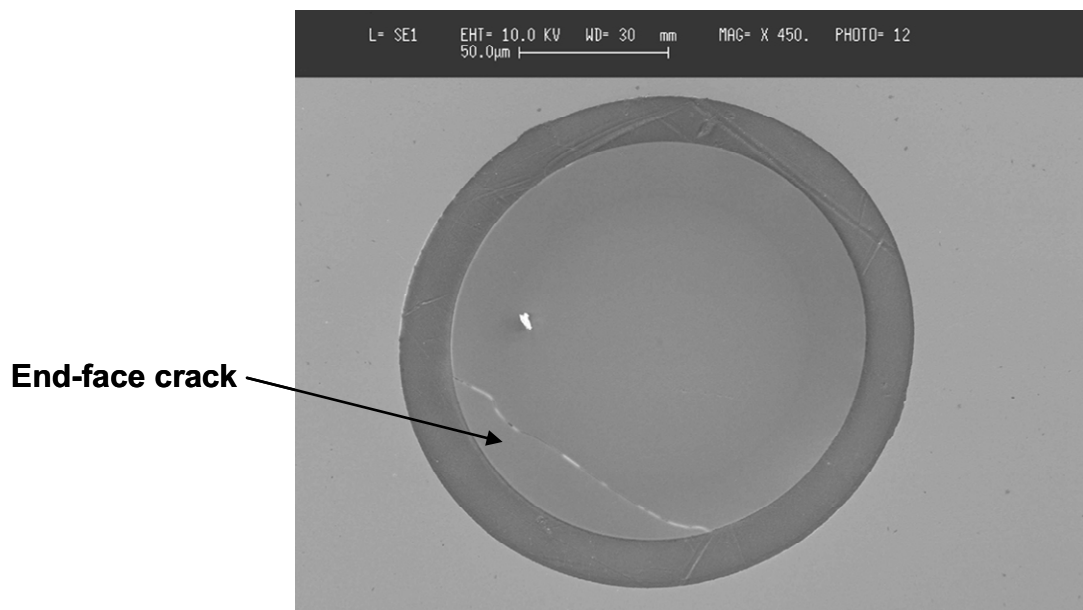
Figure 7.9-3. Crack in the End-Face

SEM shows a clearer picture of the damage (Figure 7.9-3), and what was thought to be a surface scratch becomes a crack in the end-face. There is no obvious origin of the crack. The crack ends at the coating in two locations, and the process of de-lamination occurs (Figure 7.9-4).

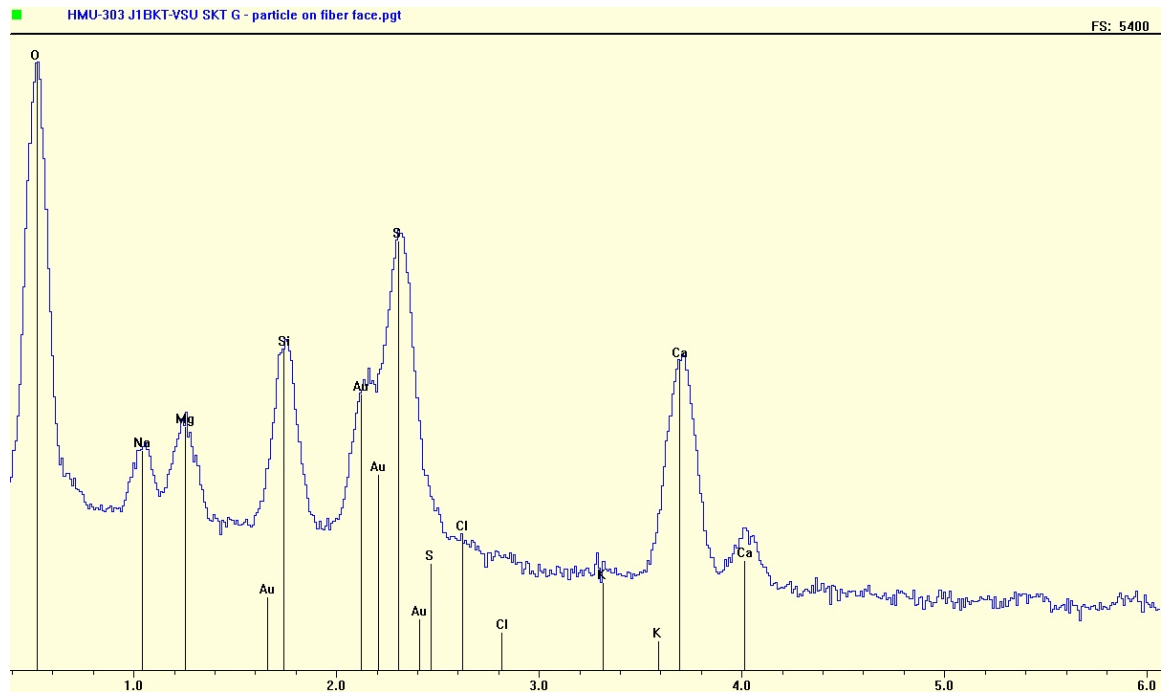
Figure 7.9-5. EDS Data of End-Face

No areas of visible corrosion were discovered, but EDS does indicate the presence of Na and Cl (Figure 7.9-5). Figure 7.9-6 shows a comparison of this EDS data to an area free of debris.

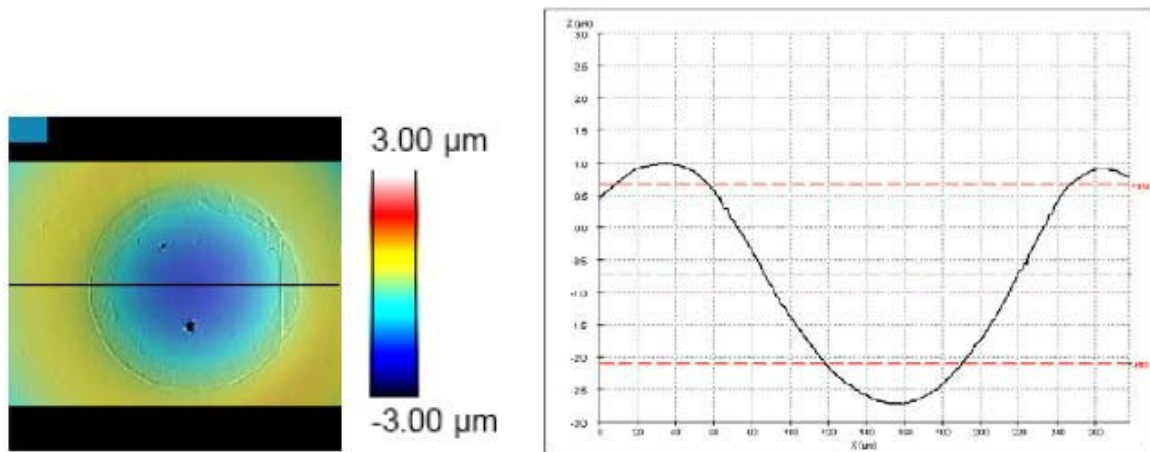
Figure 7.9-7. Confocal Data

Confocal data (Figure 7.9-7) indicates the end-face has a concave profile, with a radius of 1.1 mm.

1. The origin of the crack does not appear to be on either end, so it may have originated in the middle.
2. The formation of the scratches in the glass and coating may suggest it was mated with debris present.
3. The cleanliness of the termination was not maintained.

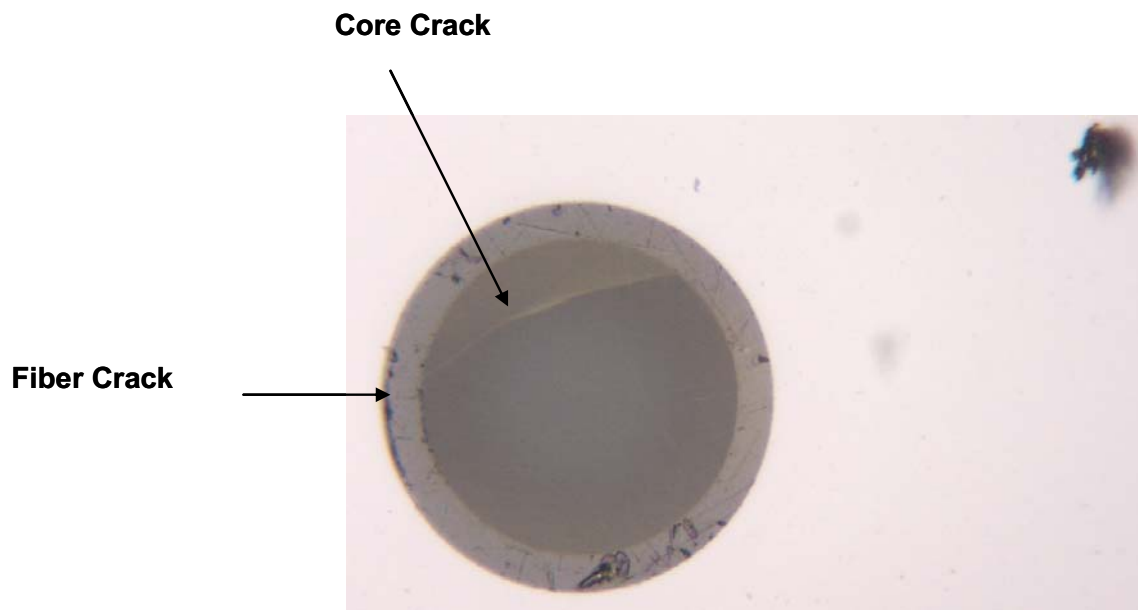
Figure 7.10-1. Bright Field Image

This termination is cracked partially through the core and deep into the fiber (Figure 7.10-1). There is some debris present on the ferrule end, and some damage/debris on the bottom of the coating.

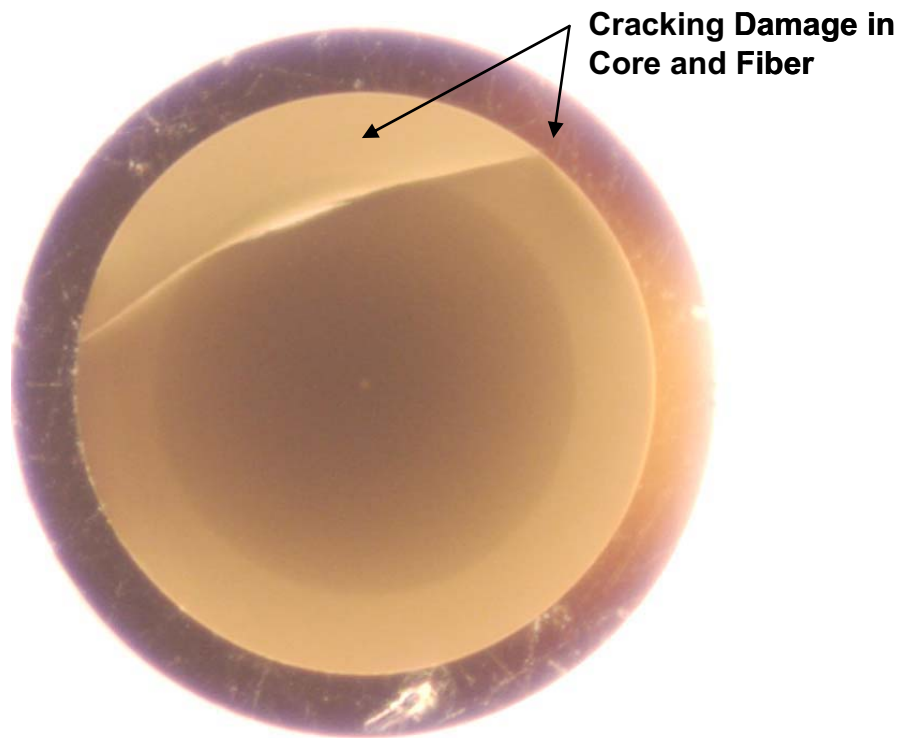
Figure 7.10-2. Dark Field Image

1. The origin of the crack does not appear to be on either end, so it may have originated in the middle, suggesting the fiber is possibly convex.
2. The cleanliness of the termination was not maintained.

This sample was unsuccessfully cross-sectioned when attempting to determine the profile geometry. The root cause of the damage could not be identified.

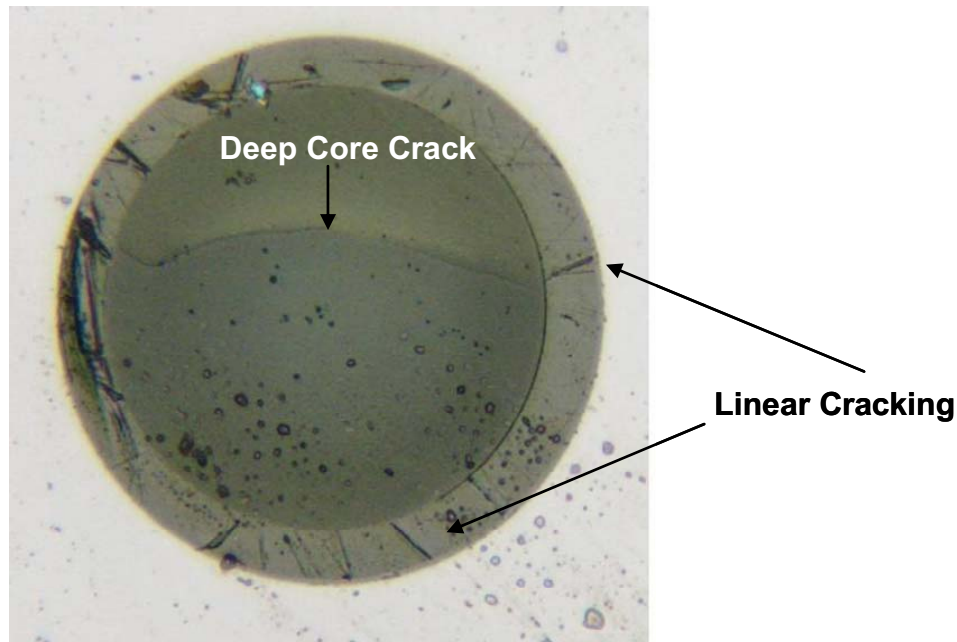
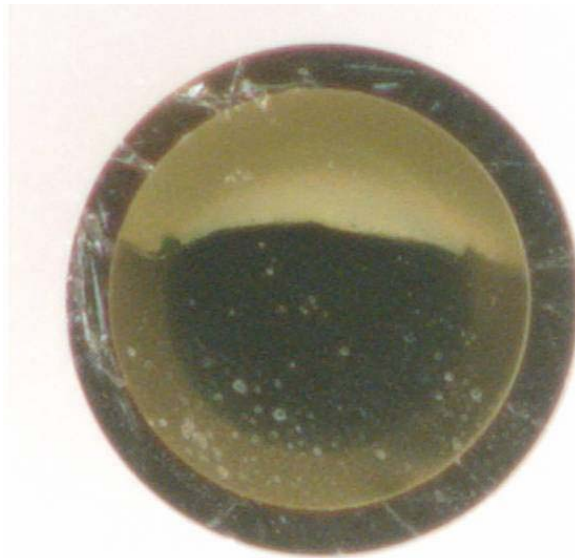
1. There was a deep crack through the core.
2. There were deep scratches in the coating, which appear linear.
